Structural and Seismic Evaluation of Existing Buildings of

**Stevens** HOSPITAL

April 15, 2010

Lund&Everton LLC
STRUCTURAL ENGINEERING

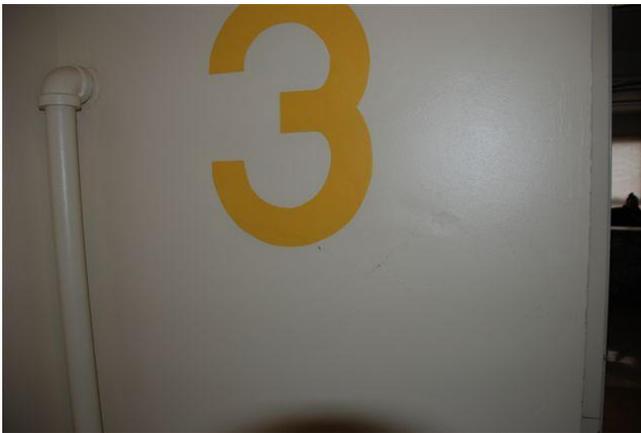
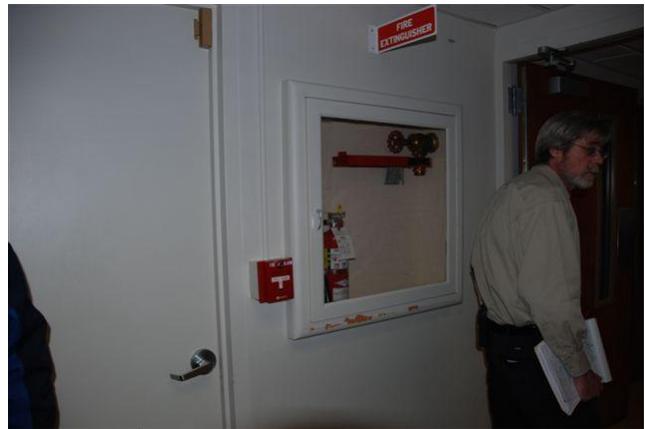
Crack in concrete wall in stair wall appears to be recent. Cause of crack is probably the 2001 earthquake. The crack occurred at this location because the concrete is quite thin behind the fire extinguisher cabinet. This is not a structural concern.

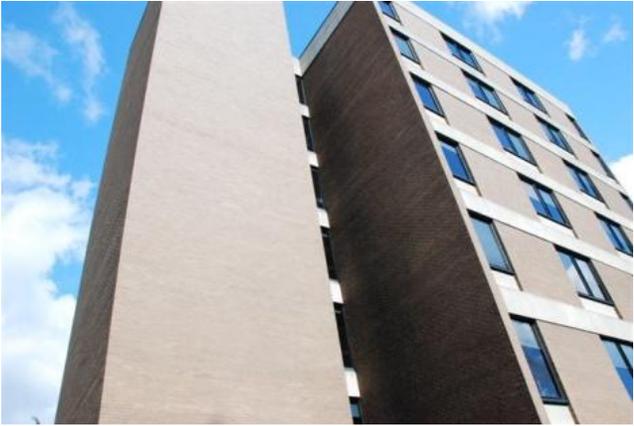
Exterior System: Brick exterior veneer does not appear to have elastomeric material at the ledger angles to allow movement between the wall panels. Brick damage and falling bricks are a potential hazard in an earthquake.

Brick exterior is in good condition but has no visible ledge angles and slip joints.

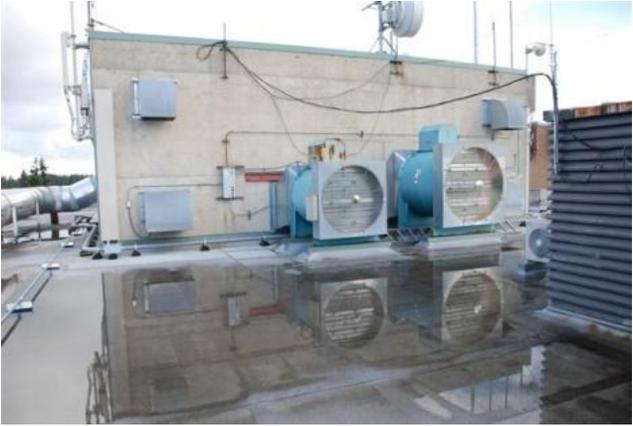
Roof drainage is poor.

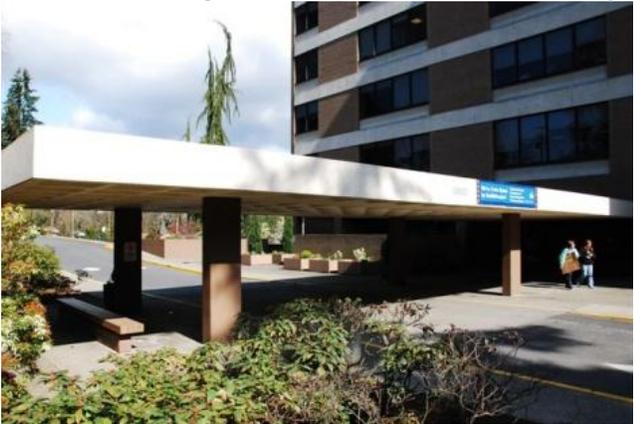
The large canopy over the main entrance is a concern for earthquake safety. It has weak columns and does not have adequate strength or ductility to resist a design level earthquake. This heavy roof is likely to collapse in an earthquake and block the primary exit of the building. We recommend seismic strengthening or removal and replacement of the canopy.

Entrance Canopy has poor seismic resistance

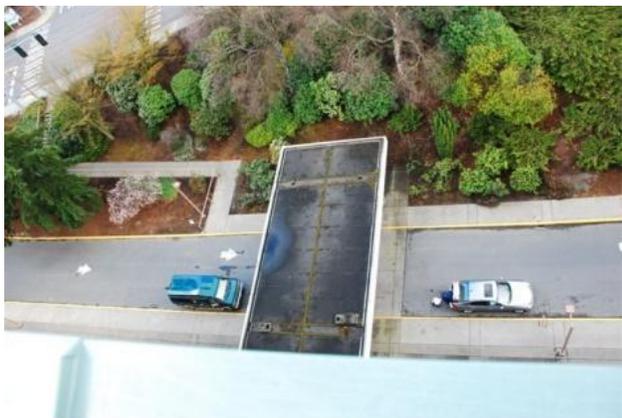
Looking down on Entrance Canopy

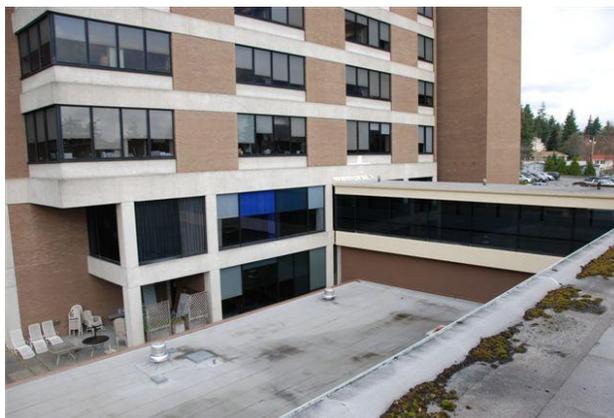
The pedestrian bridge from the Phase 3 structure, connecting to Phase 1 at Levels 2 and 3, crosses the roof of Phase 2. This bridge does not have adequate strength to withstand a design level earthquake. It is likely that the bridge will collapse. Strengthening the bridge is recommended.

Bridge at Levels 2 and 3 connecting Phase 1 and 3

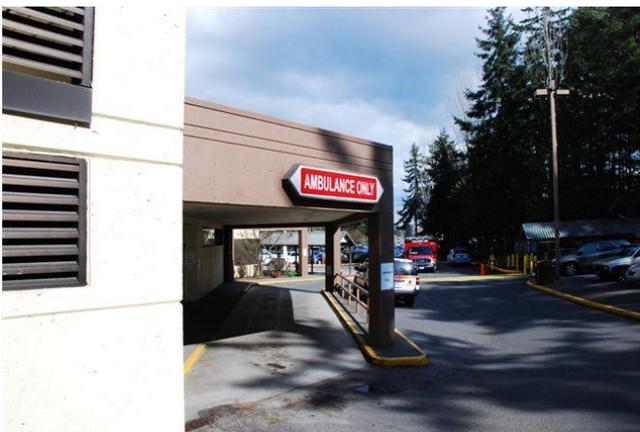
The shear walls are adequate for an immediate occupancy level of performance since the building is one story. Torsional irregularity exists but as a one-story structure it is not expected to create excessive displacements. The ambulance canopy is well tied into the roof structure and is expected to perform adequately even though the two free-standing columns do not have seismic ductility.

Ambulance canopy on southeast corner

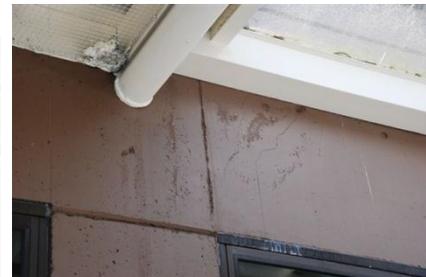
The exterior wall on the east side has cracks in the concrete headers above the windows. These headers span 42' between concrete columns. The direction of the cracks are indications of excessive shear stresses and indicate that the reinforcing in the header may not be enough for the given span. If this area is overloaded by roof load (snow, water ponding, or added mechanical equipment) there may be concrete deflection that could damage the windows below or cause structural failure. This condition should have more in-depth review.

Cracks in concrete beam

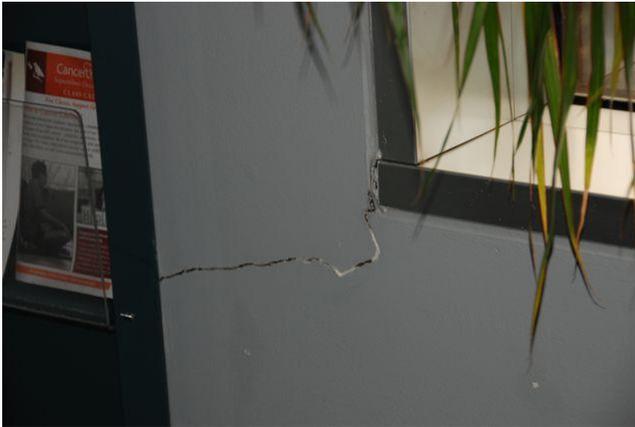
The east side lobby has significant wall board crack. The cracks in the wallboard themselves are not structural, It is not known if there is structural damage behind the cracks. The configurations of these cracks are very indicative of earthquake movement in a structure that is not adequately braced for an earthquake. In this building the problem is torsion due to the thick walls on one end of the building and the complete lack of any seismic resistance on the east end of the building. The problem was compounded by the lack of separation joints in the wallboard in the two story spaces of the lobby.

Cracks in non-structural wall board

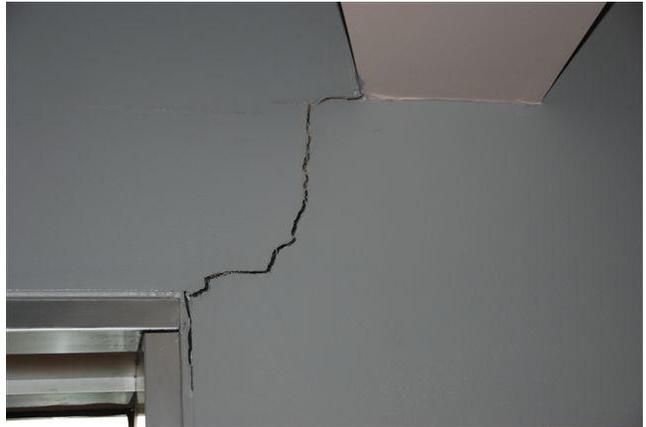
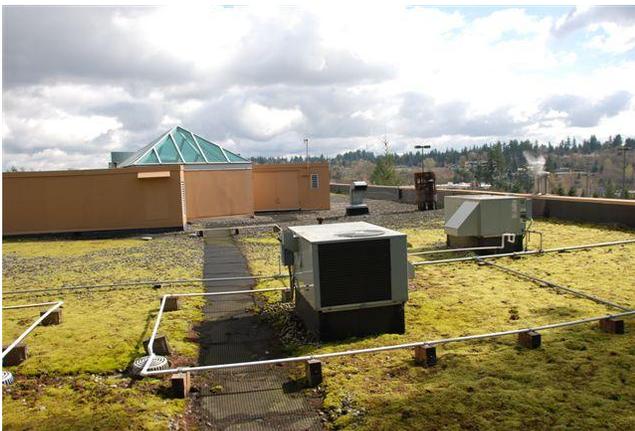
No deterioration of structure is visible. The north end of the roof is heavily covered with moss. This will keep the roof from draining properly and cause excessive water ponding that may overload the roof and lead to water intrusion and potential structural damage. Maintenance is suggested to not only kill the moss but clean out the organic matter that impedes drainage.

Moss on roof may cause excessive loads, this north section is shaded

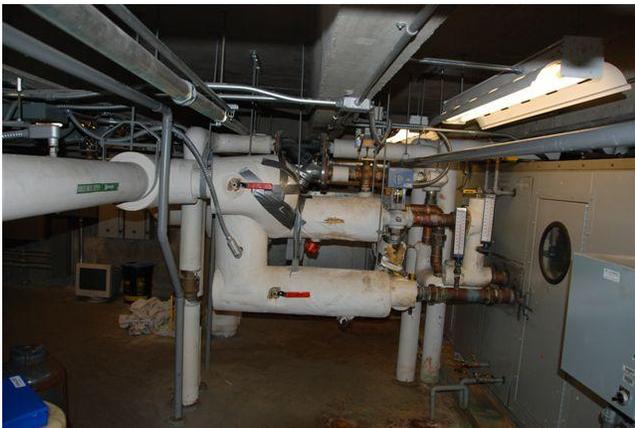
Piping in mechanical spaces is not braced

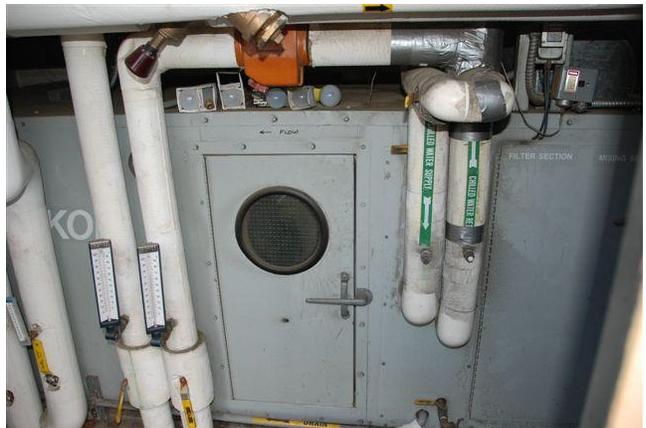
We noticed that the mechanical equipment sitting on grade outside of the Oncology building was not bolted to the supporting slab. The penthouse units were observed but we could not determine if they were anchored. Piping in the building was not braced. Seismic anchoring and bracing would improve the buildings life safety. This would be advisable to maintain services in the building if structural improvements are to be made.

Equipment may not be anchored

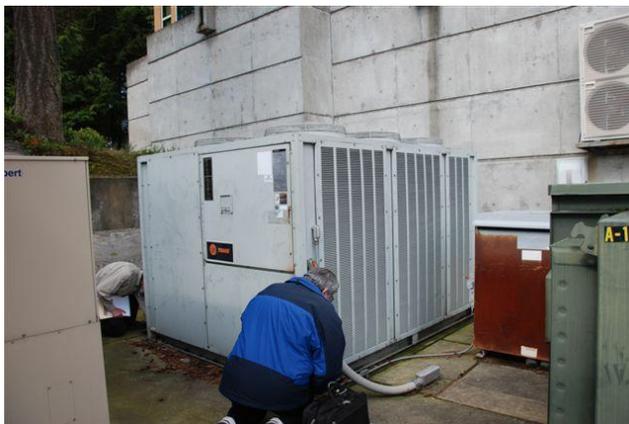
Air handling equipment is not anchored

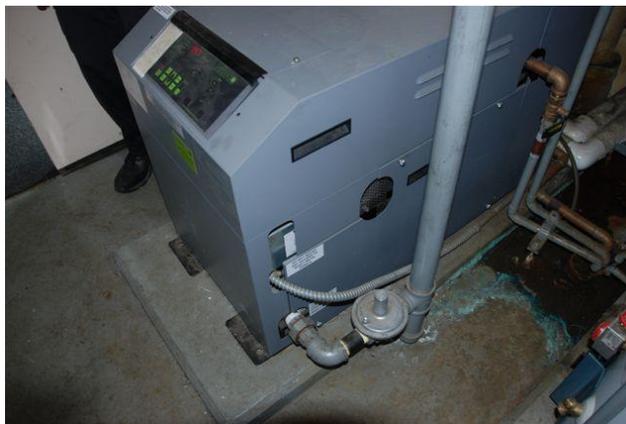
Some equipment is not anchored

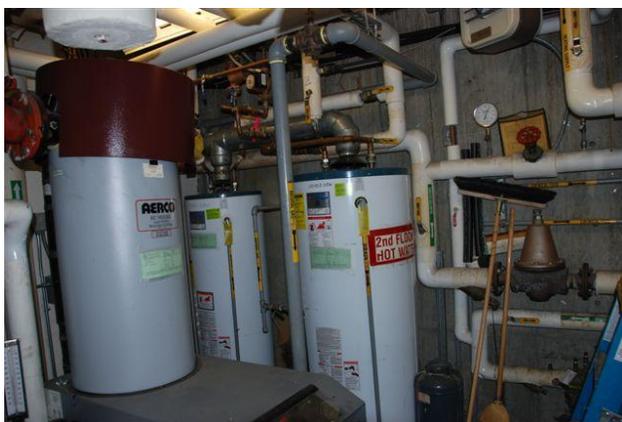
Water heaters are not anchored

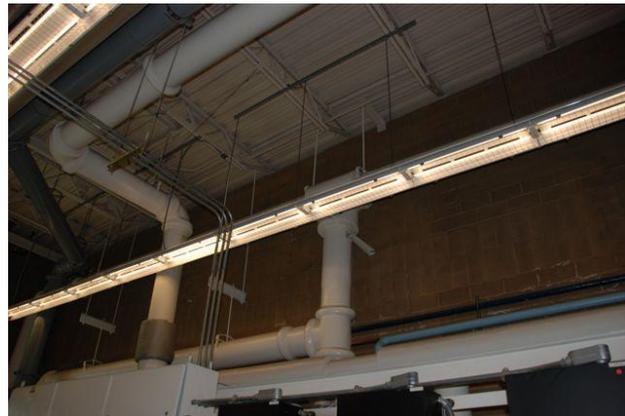
Non-structural systems are expected to perform well. All equipment is anchored at the floor. Distribution systems are braced however some bracing of piping hanging from the roof appears to be braced to the bottom flanges of open-web steel joist that do not have any lateral support. Excessive movement of the piping may occur and cause breakage and loss of services.

Some piping hanging from the roof is not adequately braced.
